Bulletin No.: 10-08-42-001D

Service Bulletin

Subject: Low Beam Headlamp Bulb Diagnosis/Replacement (Inspect Bulb and Connector)

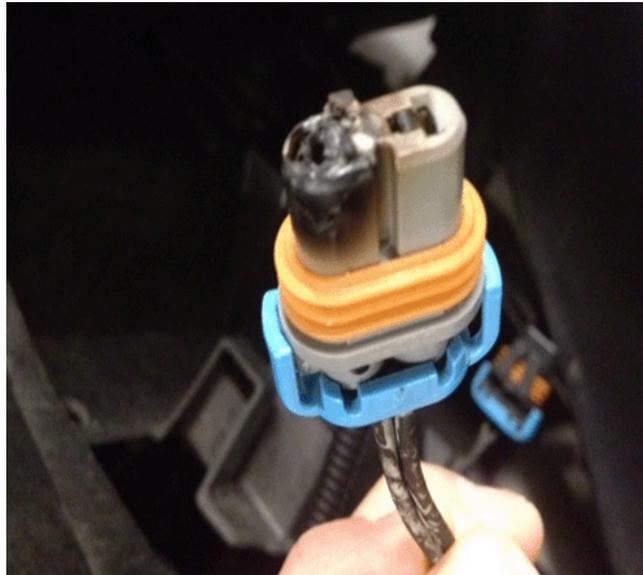
3991128

- If the connector is discolored at the bulb interface, replace the connector (service pigtail listed below) and bulb.
3. Cut the wires of the connector approximately 45 mm (1¾ in) from the connector and splice in the service pigtail connector. Ensure that the splices are not above the connector when re-installing.
